USACERL Technical Report 98/47
February 1998

CONSTRUCTION PRODUCTIVITY ADVANCEMENT RESEARCH (CPAR) PROGRAM

Fiber-Reinforced Polymer Composite Materials Systems to Enhance Reinforced Concrete Structures

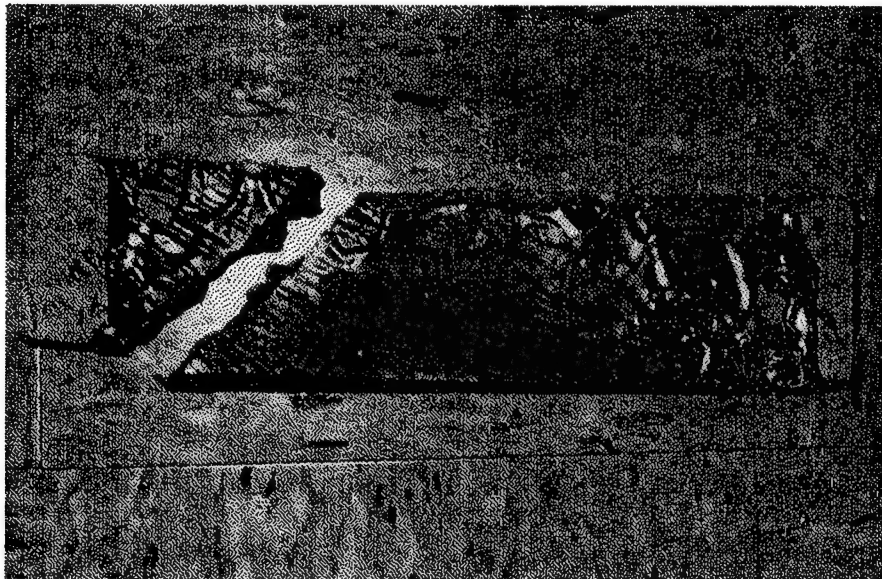
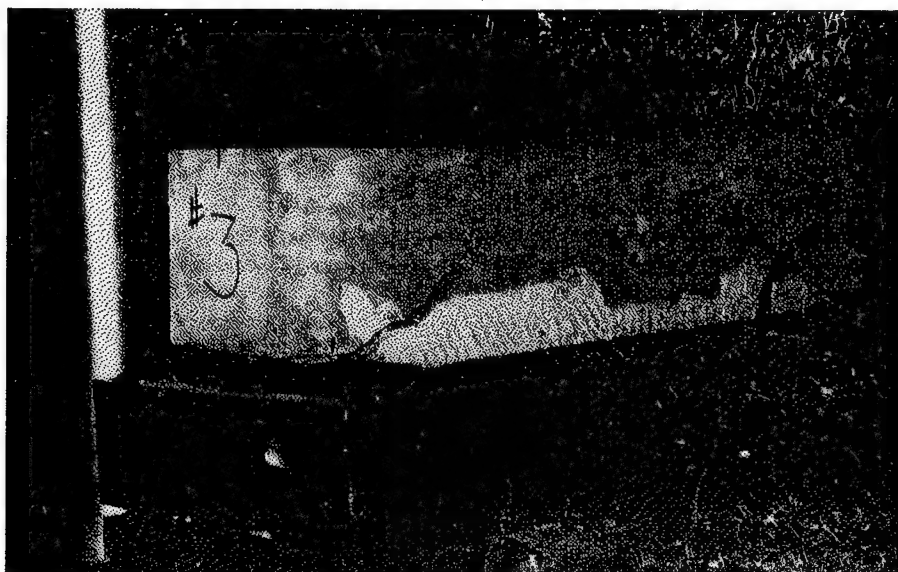
Figure E62.1

Figure E.62.1 - E.62.5 Diagonal shear crack propagation in the thermally cycled beams bonded with CFRP.
